# Fluidic functional verification for closing structures and fluid-based sealing of the contact zone STROEFUN III

Julius Bauermeister, Nina Müller-Hoeppe  
TU Clausthal, BGE Tec

**US/GERMAN WORKSHOP**

Salt Repository Research,  
Design, & Operation

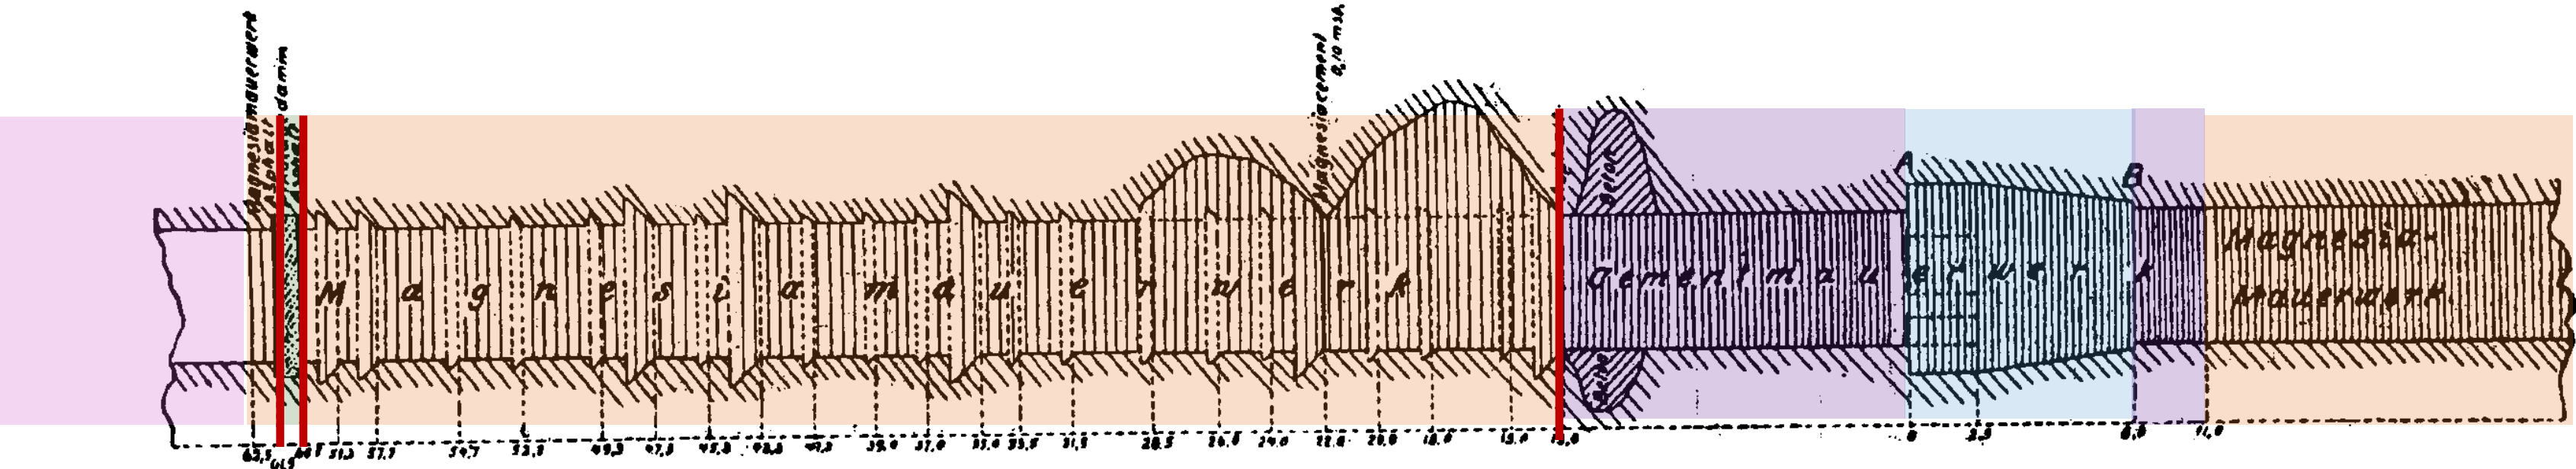
In 1898 the 161,5 m long drift seal in the Leopoldshall salt mine – cross-cut between Leopoldshall I/II and Leopoldshall III was built

- Brick masonry with cementitious mortar (existing part)
- Brick masonry with cementitious mortar (new part)
- Brick masonry with MgO-mortar separated by
- Asphalt gaps
- Pikotage dam
- Saturation chamber (crushed carnallite)

Before the sealing body was erected the drift contour was removed up to 1 m and subsequently washed with  $MgCl_2$ -rich brine ... the miners worked on an empirical basis ... but the seal became effective

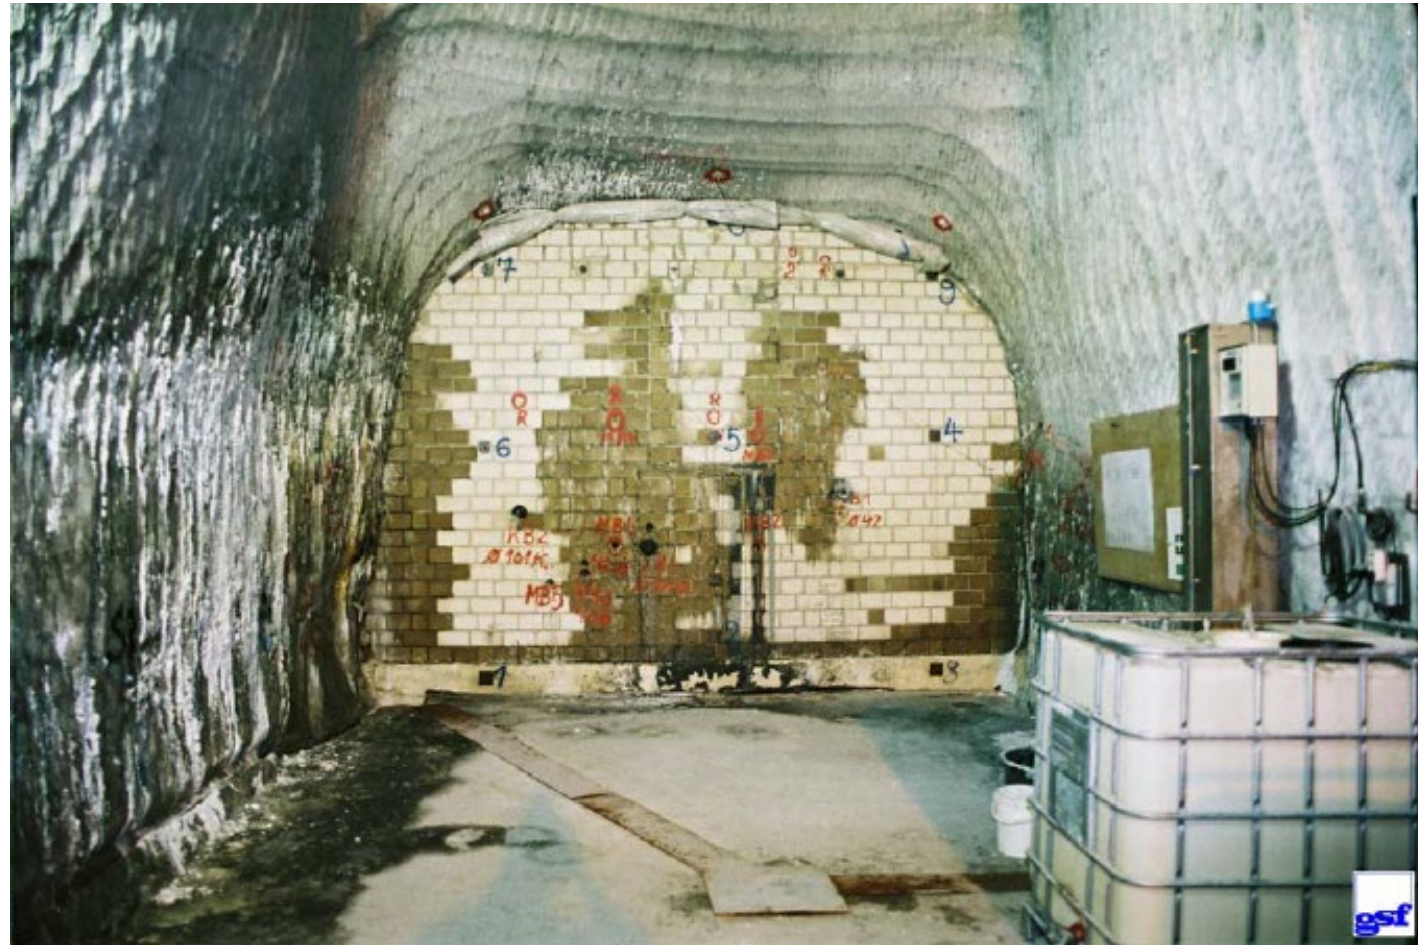
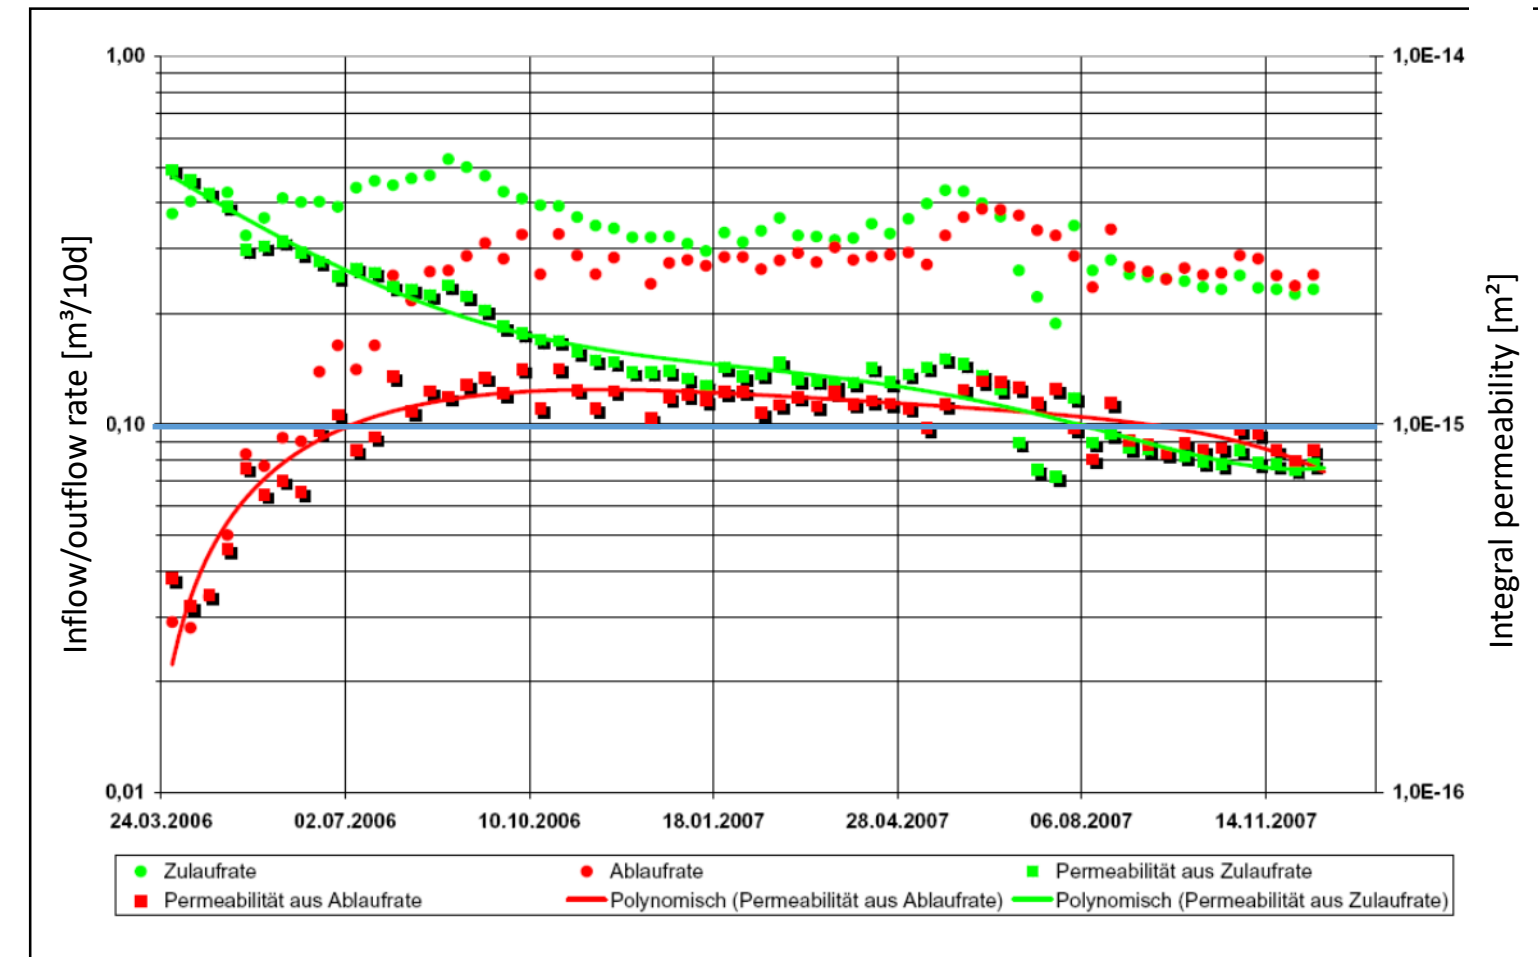
# Asse Mine Prototype Testing – Pilot Seal A2

About 100 years later ... in order to demonstrate proper functionality prototype testing was required by mining authority constituting a prerequisite to close the Asse Mine ...

- Removal of EDZ according to mining experience was not sufficient
  - Selection of a low permeable but „soft“ building material was not favorable
- EDZ acted as a preferential pathway

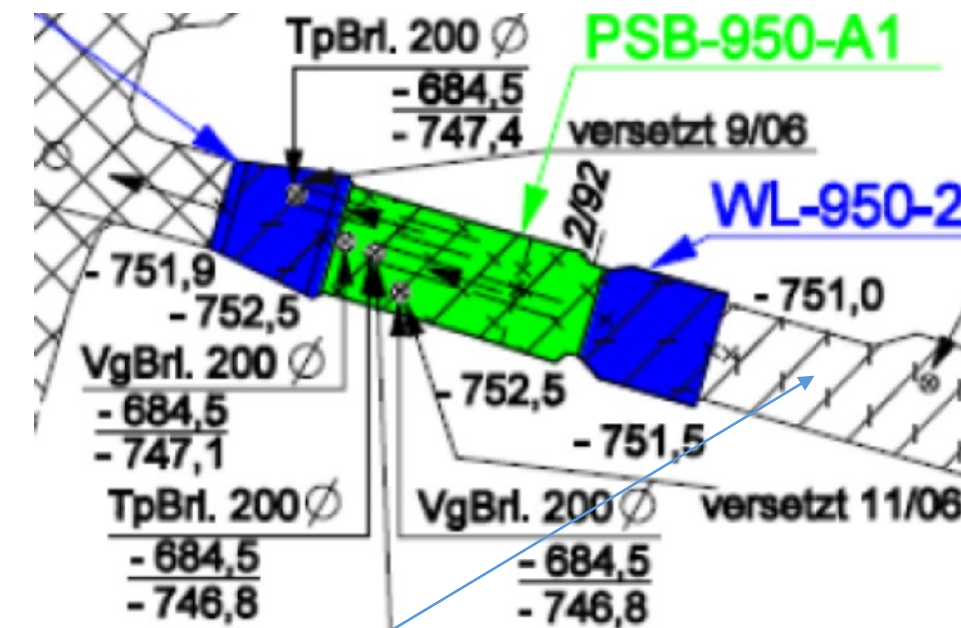
# Asse Mine Prototype Testing – Pilot Seal A1

- Removal of EDZ based on measured values
- Selection of a „stiff“ building material for the sealing body

And to gain deeper insight extended installation of measuring devices – temperature, total pressure, pore pressure

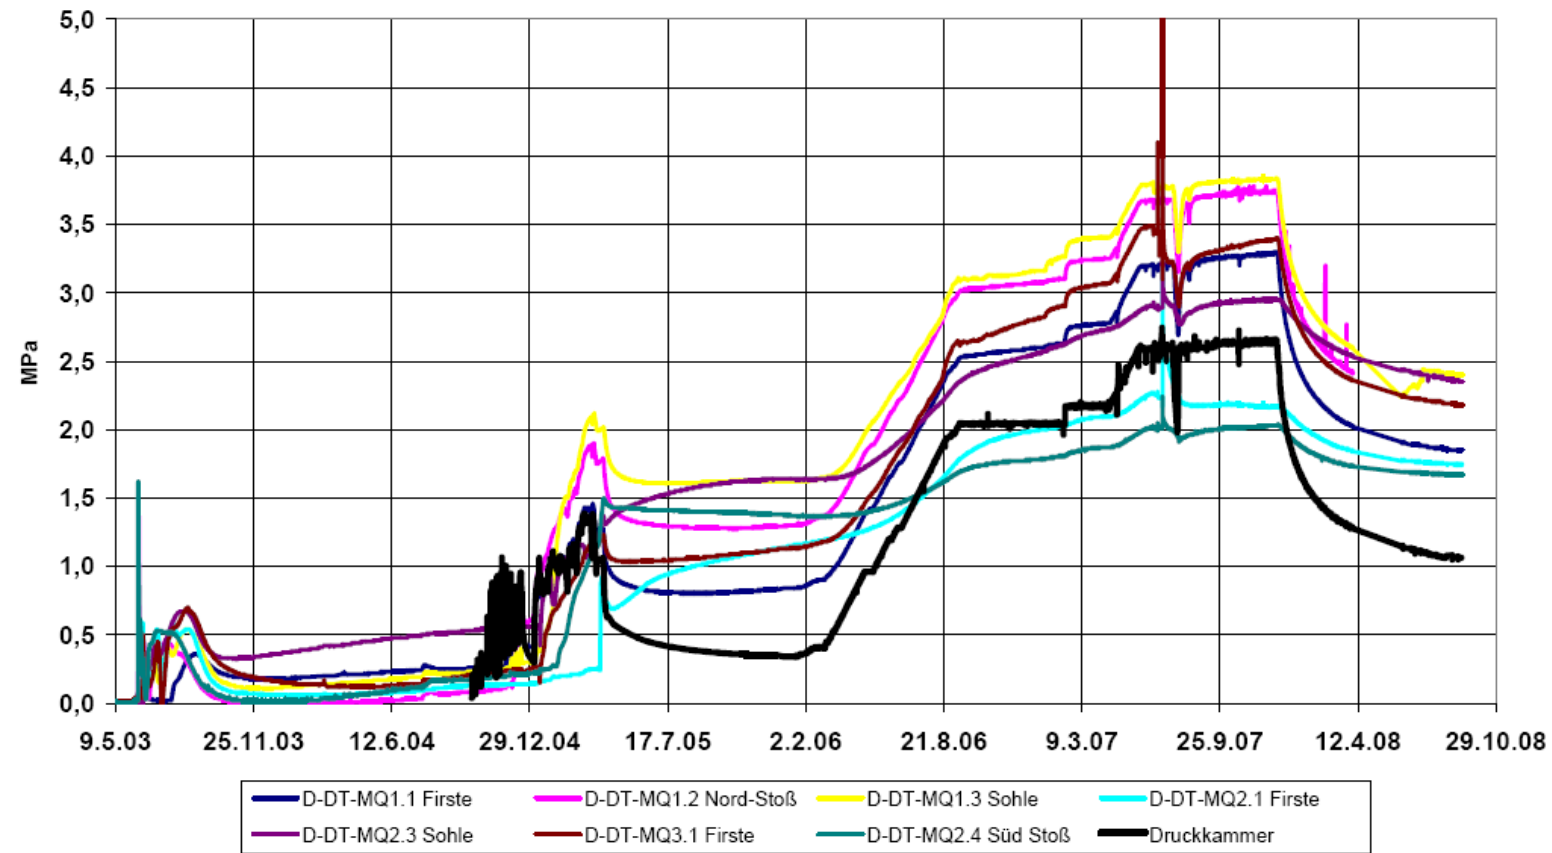
Pilot Seal A2 – if the pump stopped pressure decreased immediately

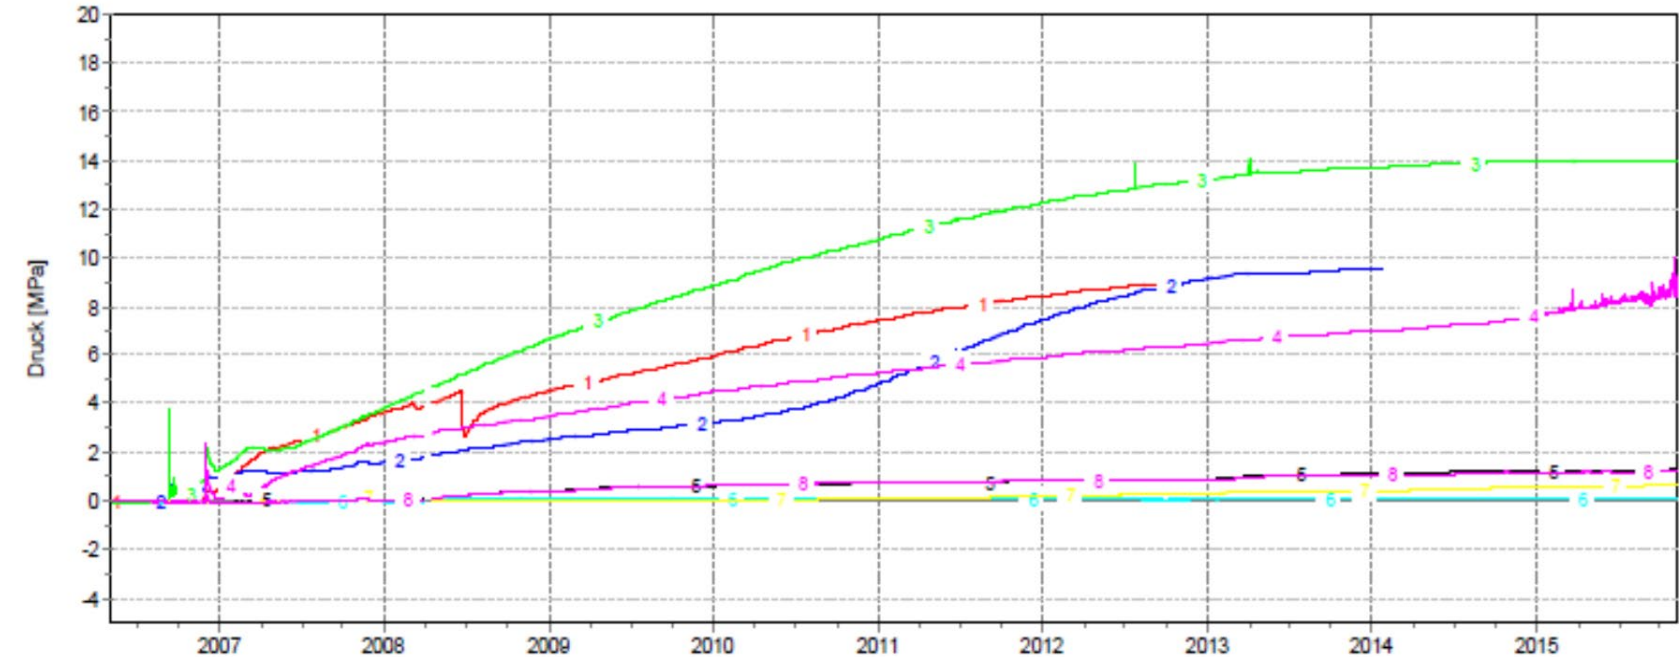
Pilot Seal A1 – if the pump stopped no pressure decrease was detected

Pilot Seal A1 showed improved tightness → PSB A1 design was selected for routine application

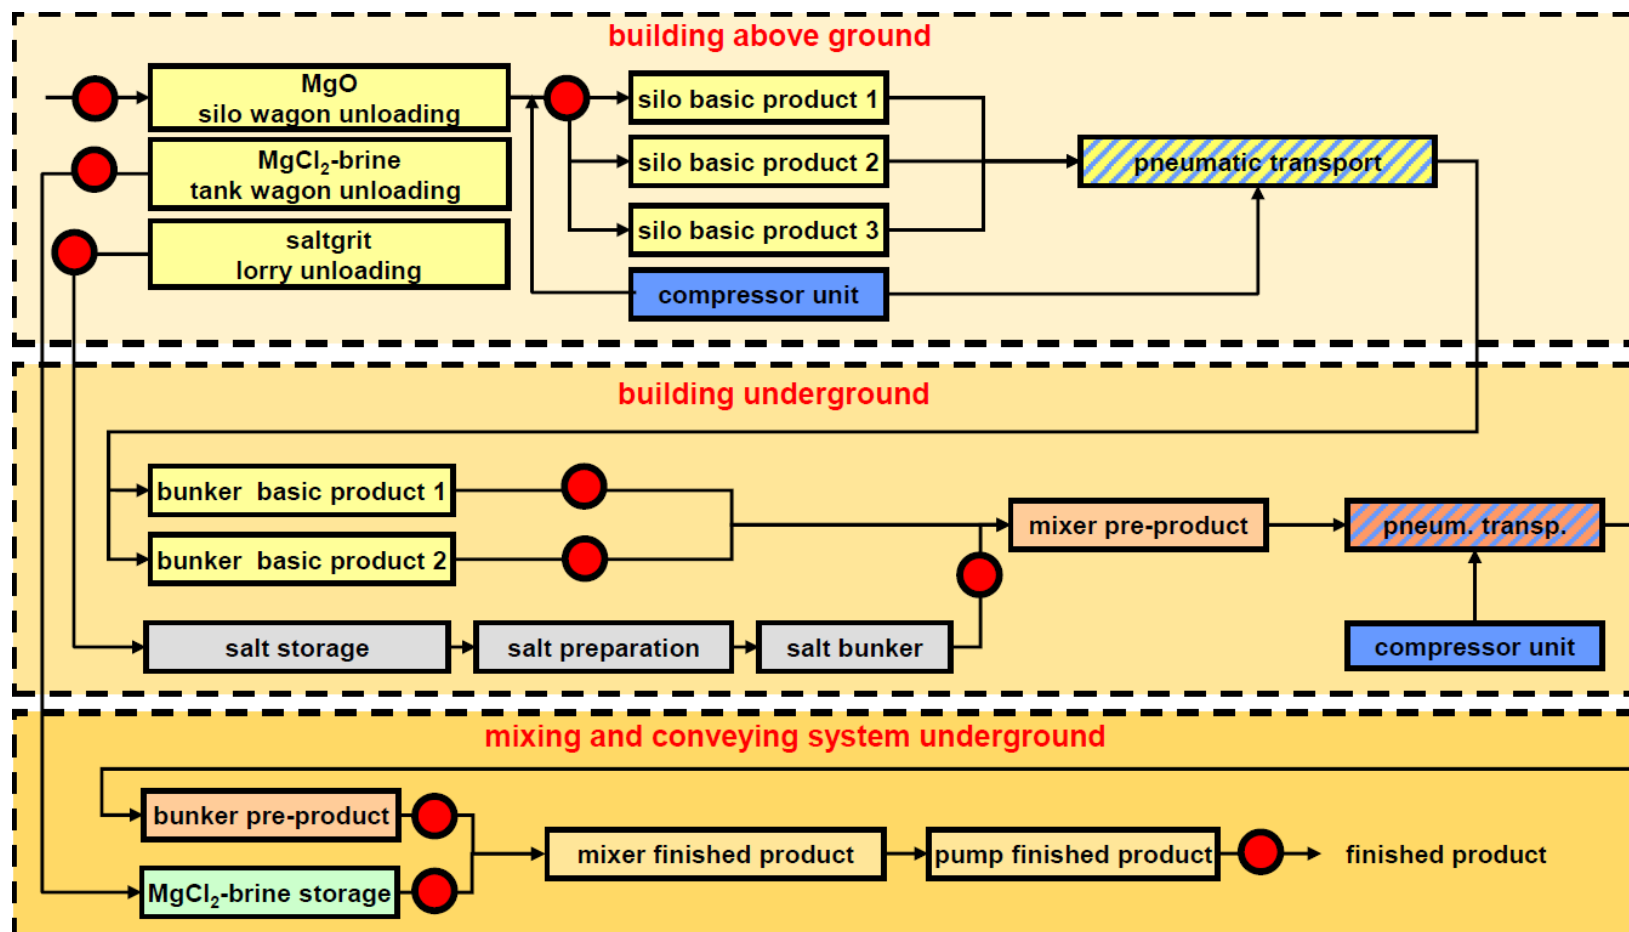
Example: Production and quality assurance of A1 suspension

● Sampling for quality assurance of building material

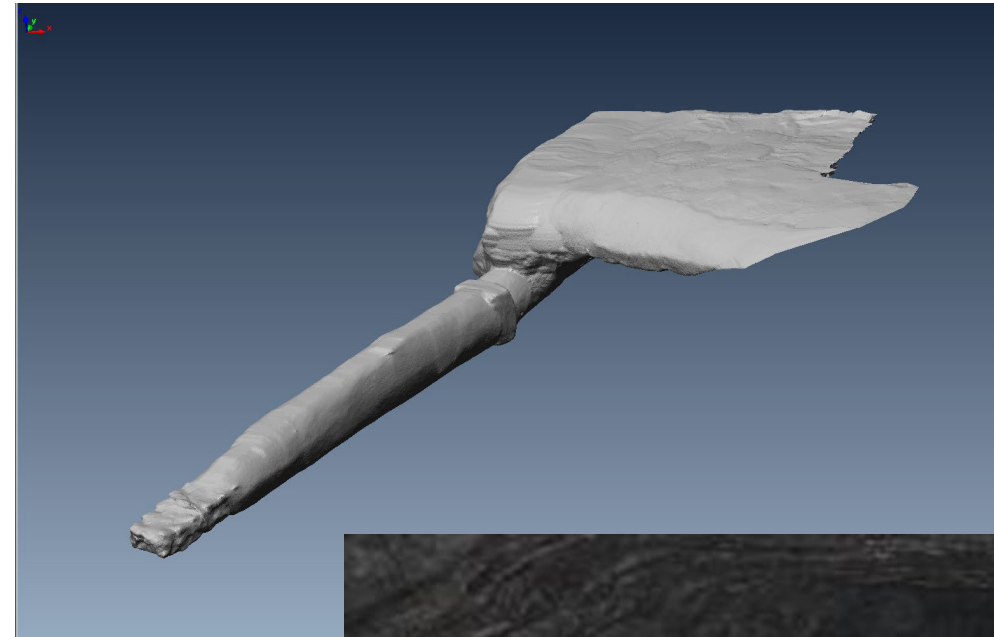
3D-laserscan of a re-ripped drift seal location

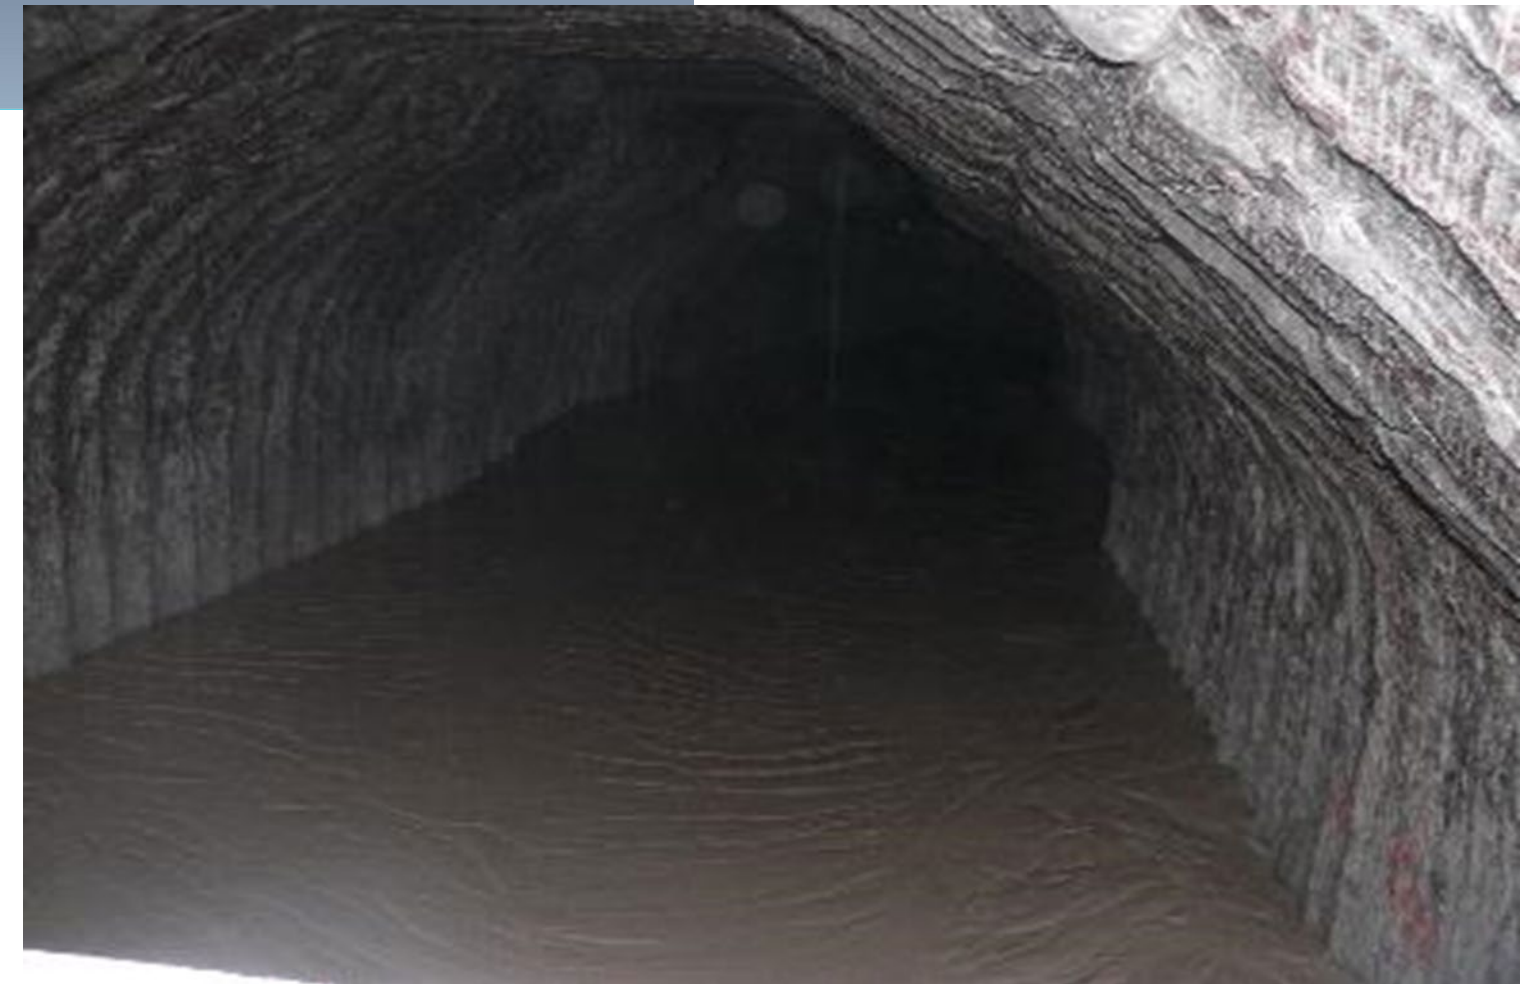
Casting of sealing body

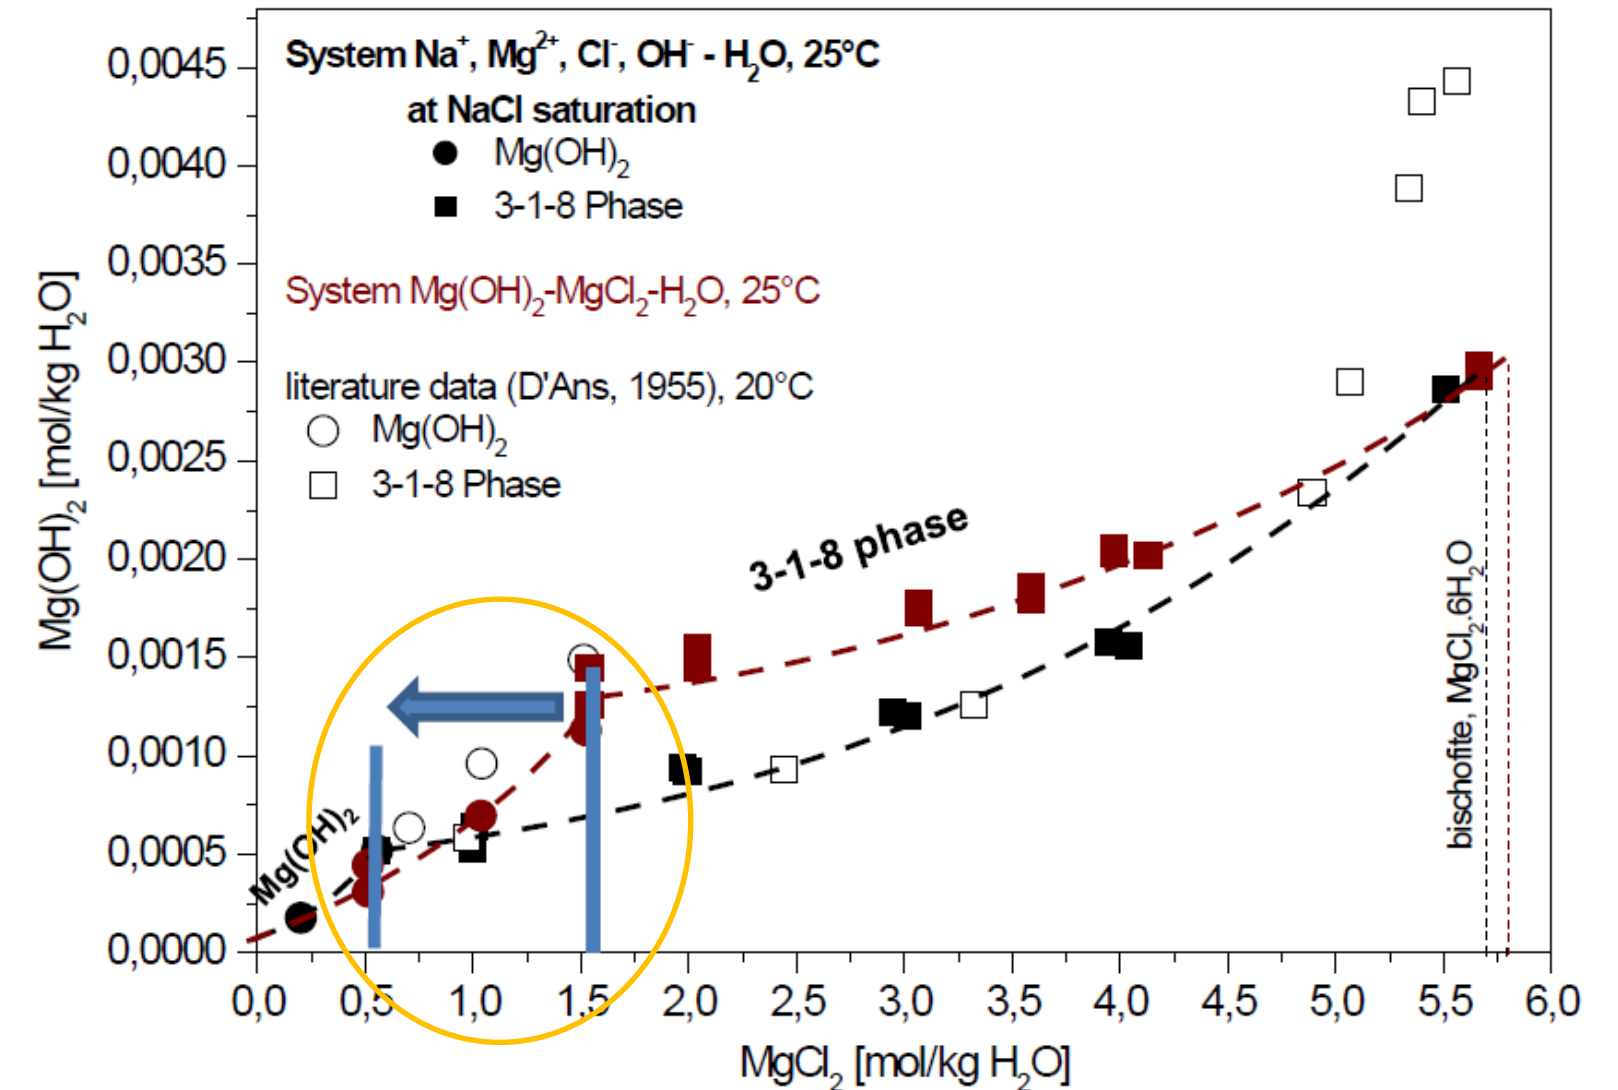
- 3-1-8 phase – thermodynamically stable up to  $80^\circ\text{C}$
- At higher temperatures 9-1-4 phase
- 5-1-8 phase metastable – no stability field exists

- At NaCl saturation the stability field of the 3-1-8 phase is extended to  $0.5 \text{ mol Mg}^{2+}/\text{kg H}_2\text{O}$

... System  $\text{Na}^+, \text{Mg}^{2+}, \text{Cl}^-, \text{OH}^- - \text{H}_2\text{O}$  at  $25^\circ\text{C}$

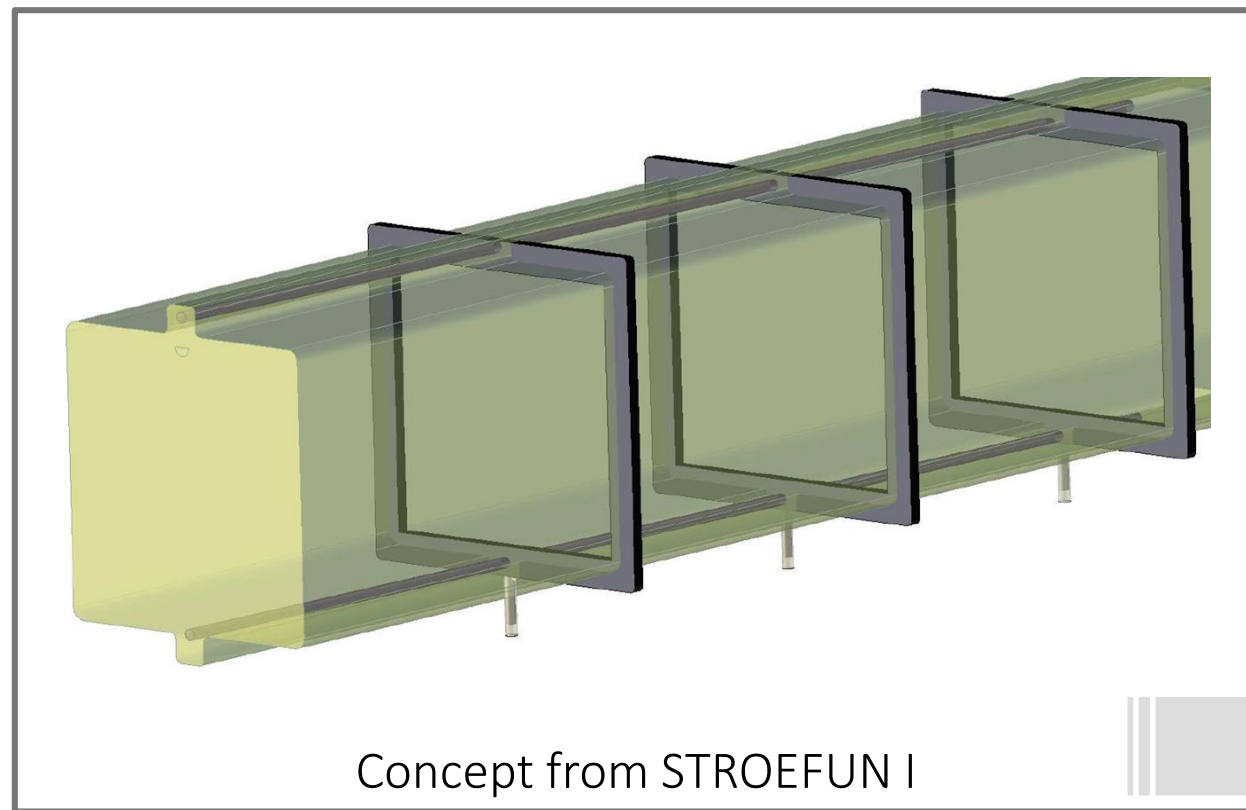
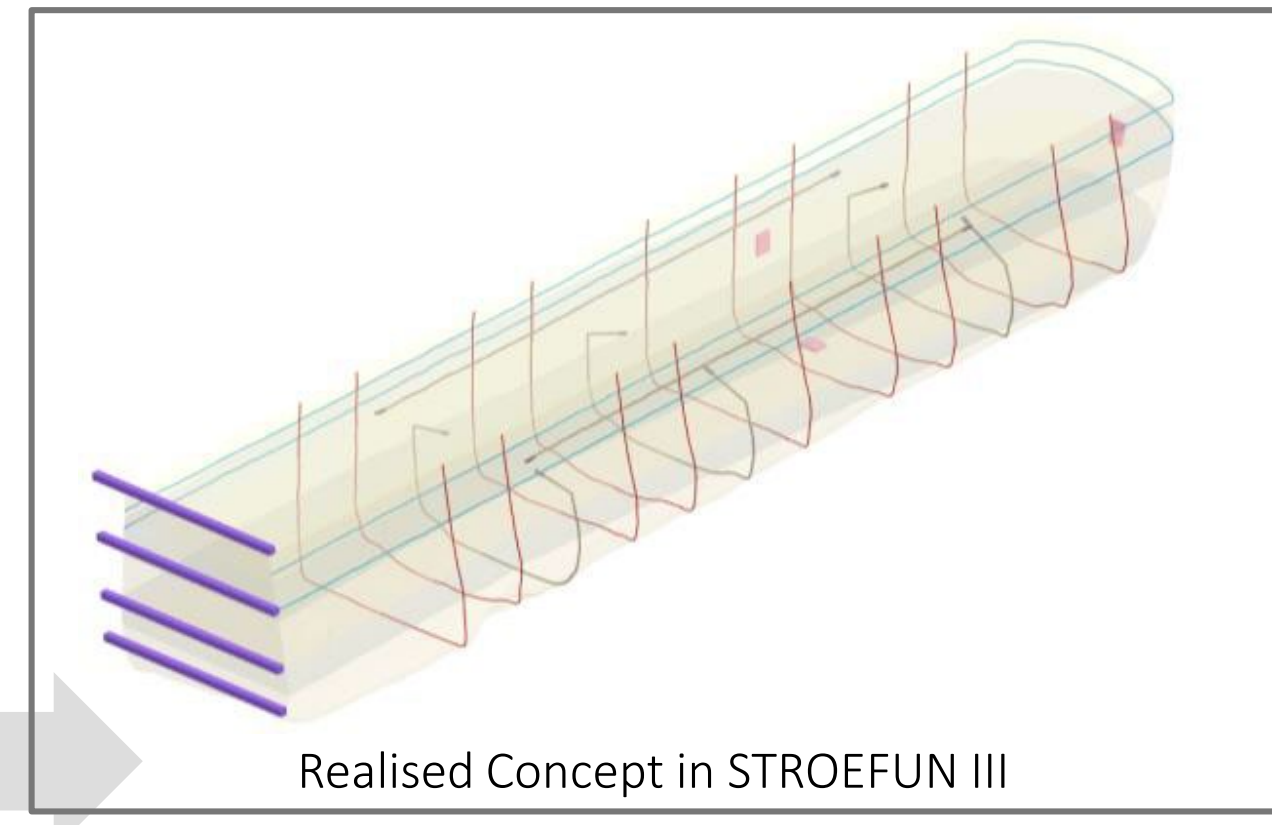
- Control chambers which can estimate the integral permeability between each other
  - Air pressure wave is applied to the contact zone
  - Monitored by the chamber system along the rock contour

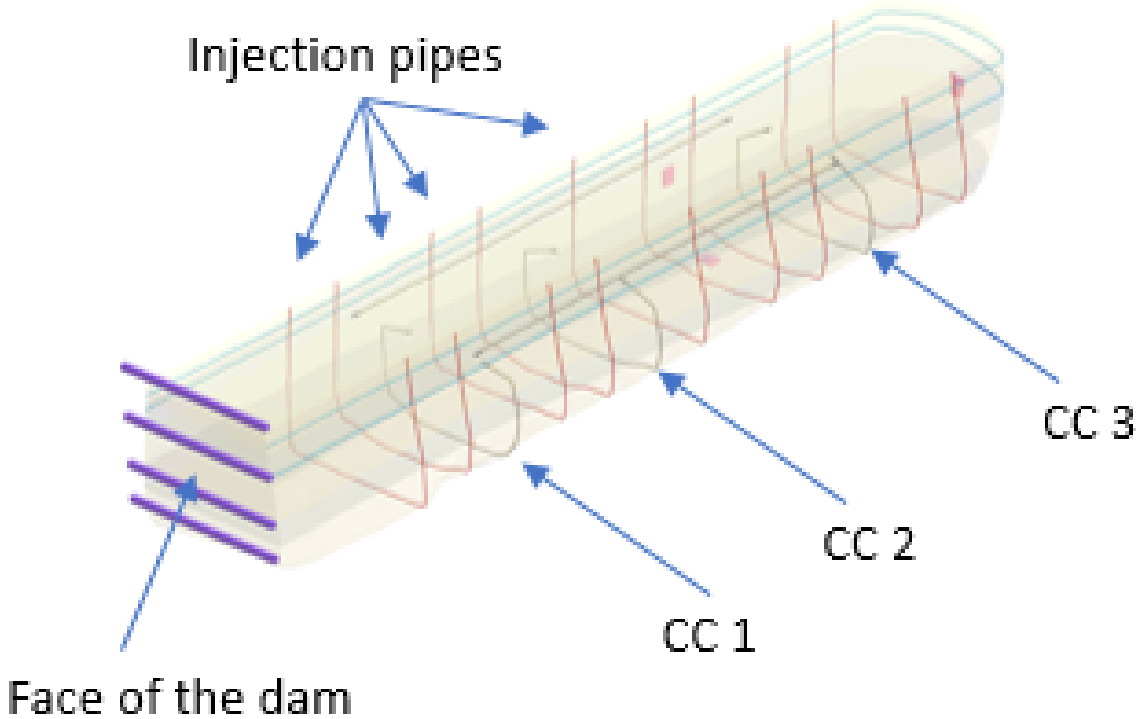
Overview of the installed measurement, test and injection infrastructure

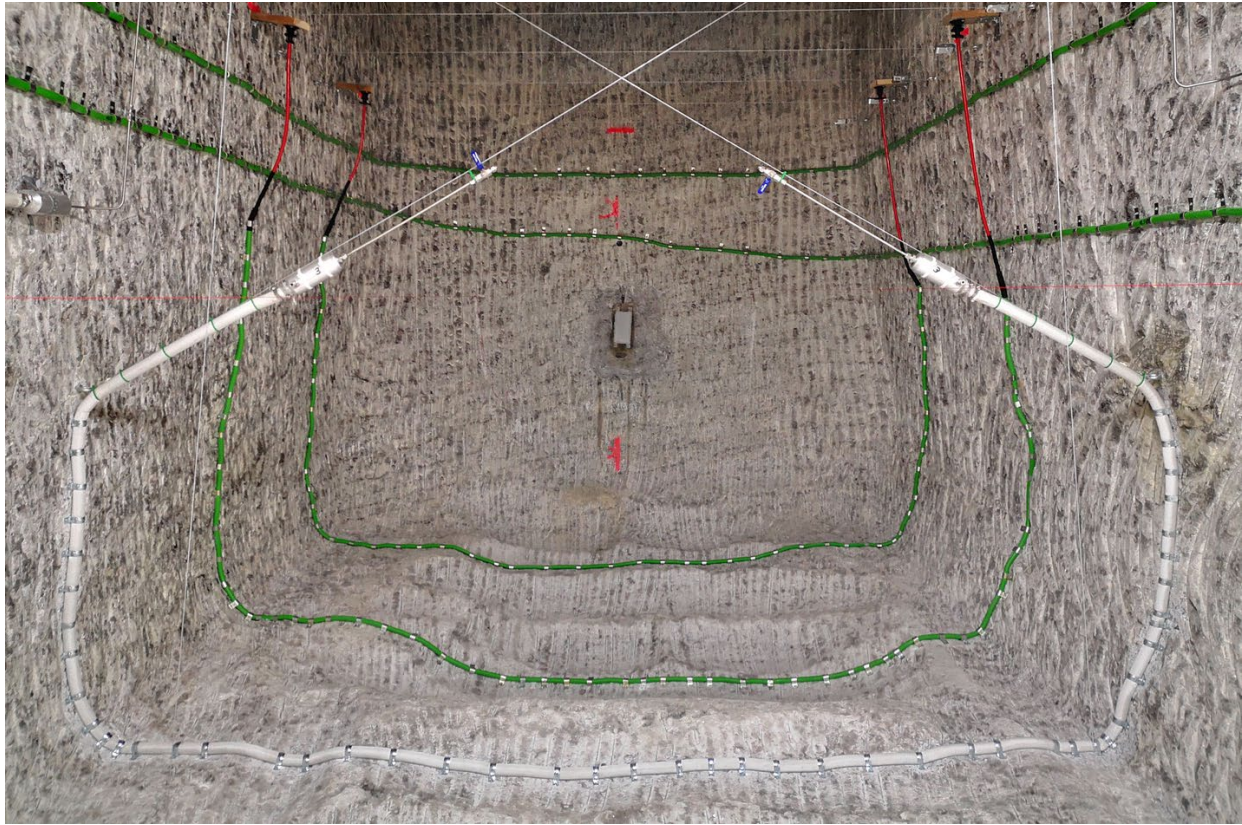
Pre-installed CC3 (without connecting pipes)

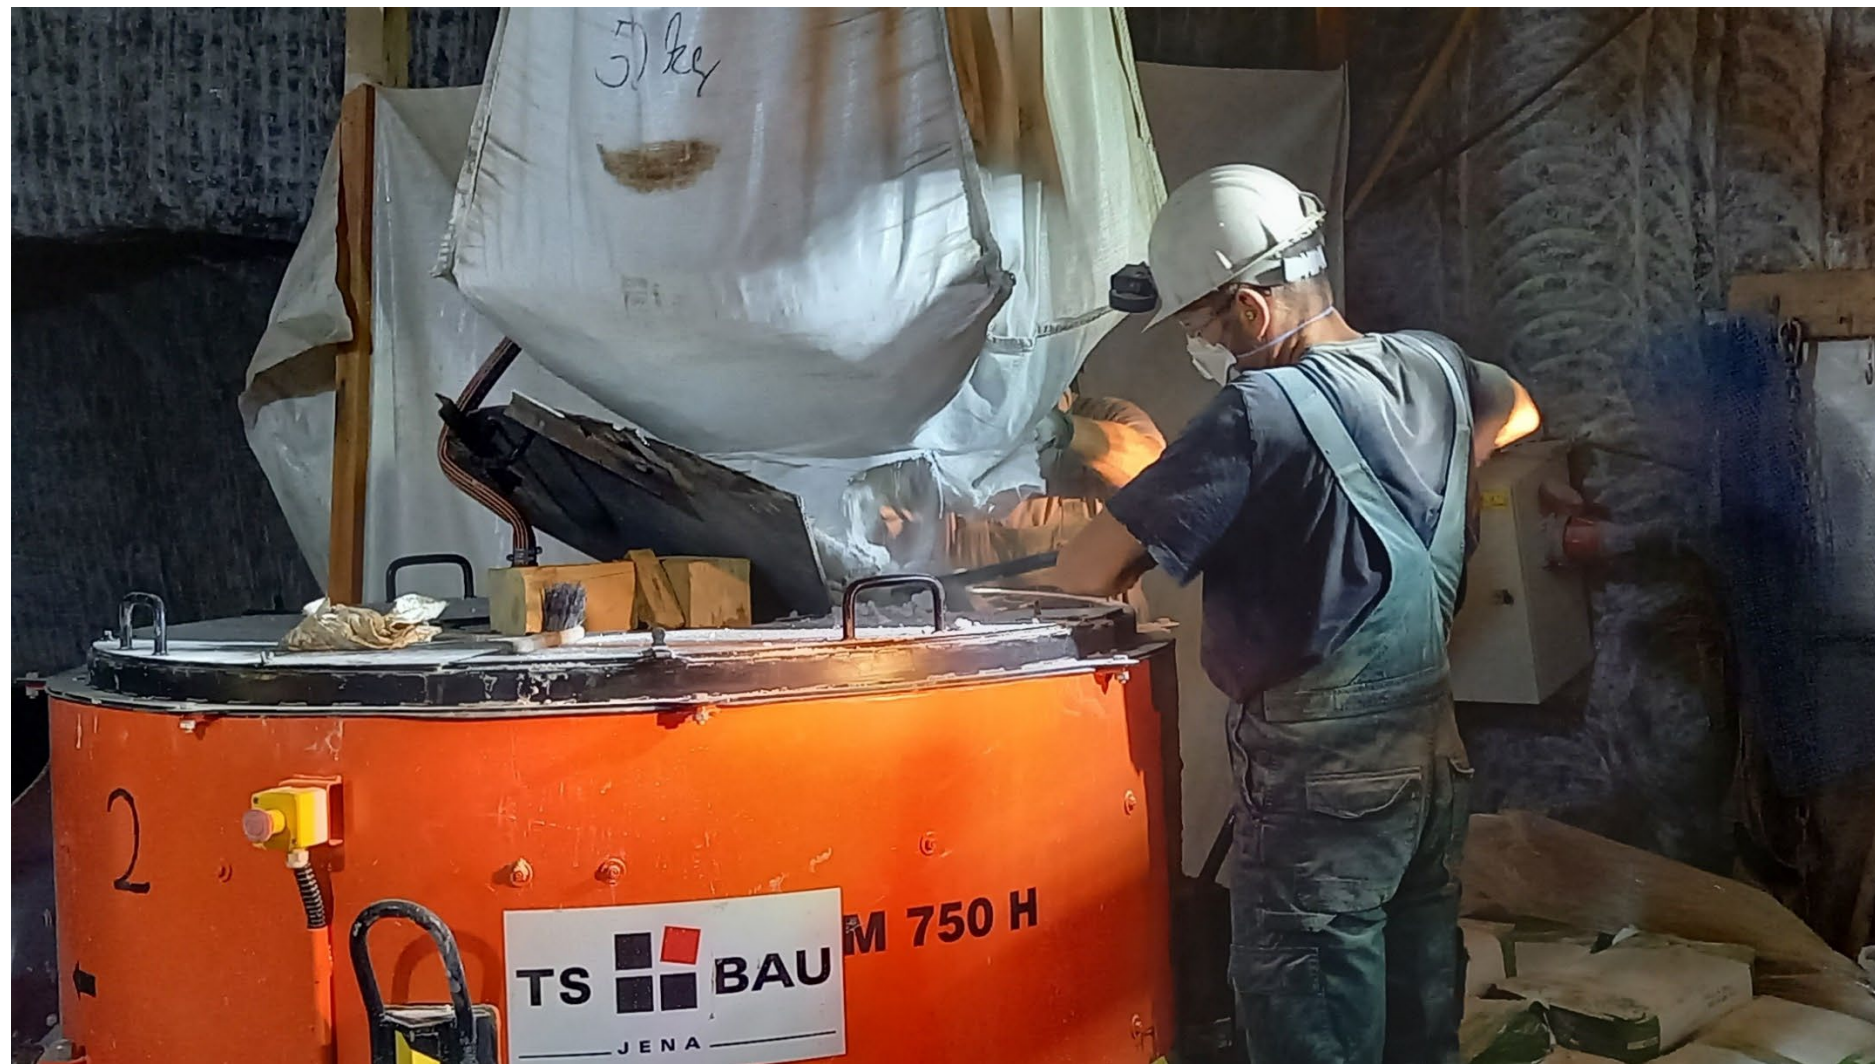
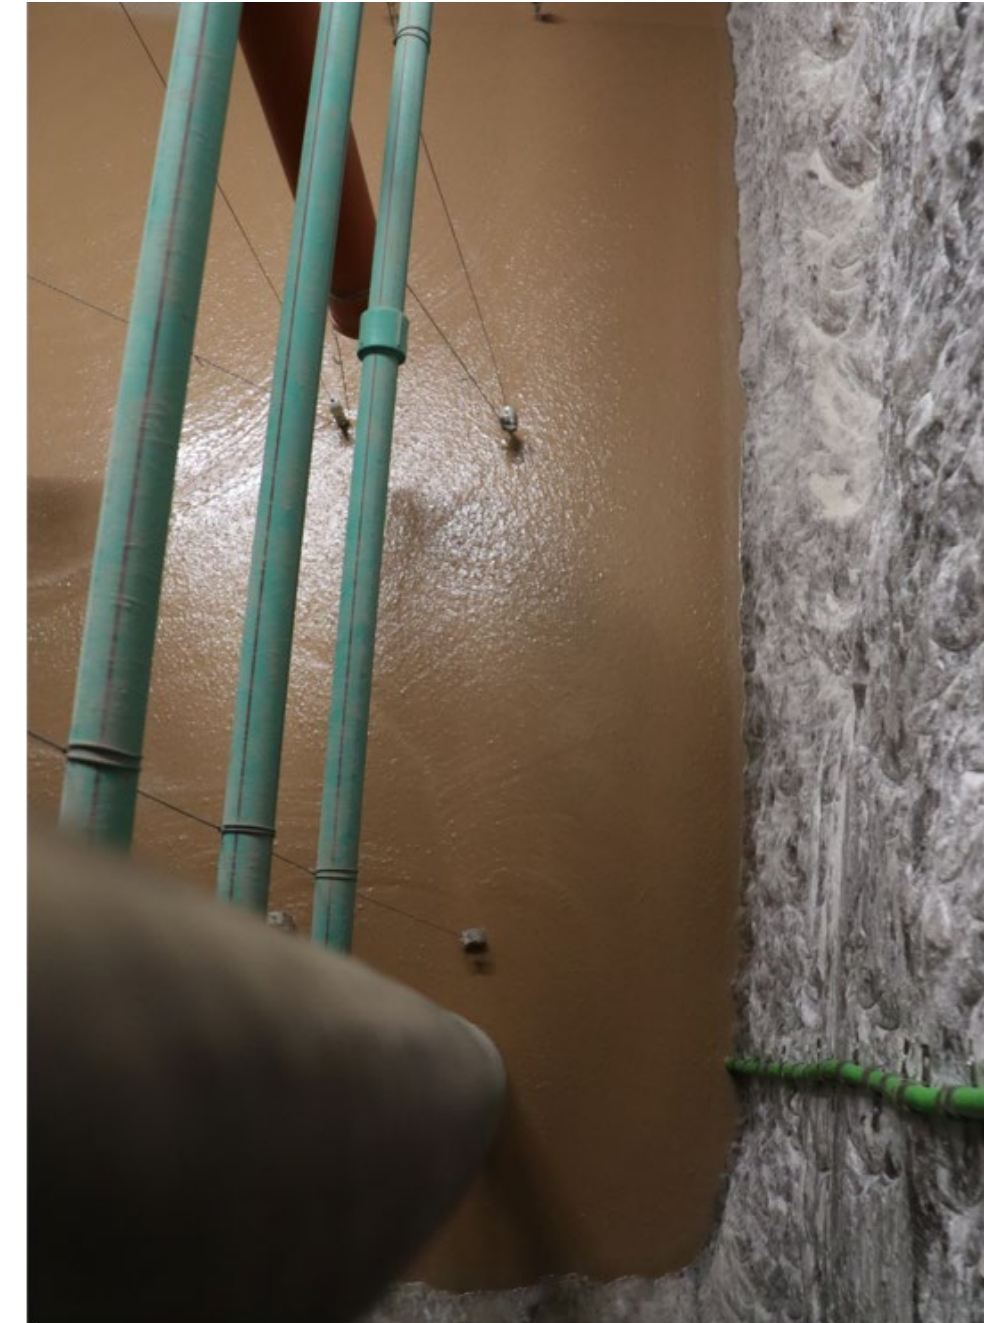
- The concrete is based on the A1-recipe from the BGE Tec
  - Anhydrate as an additive

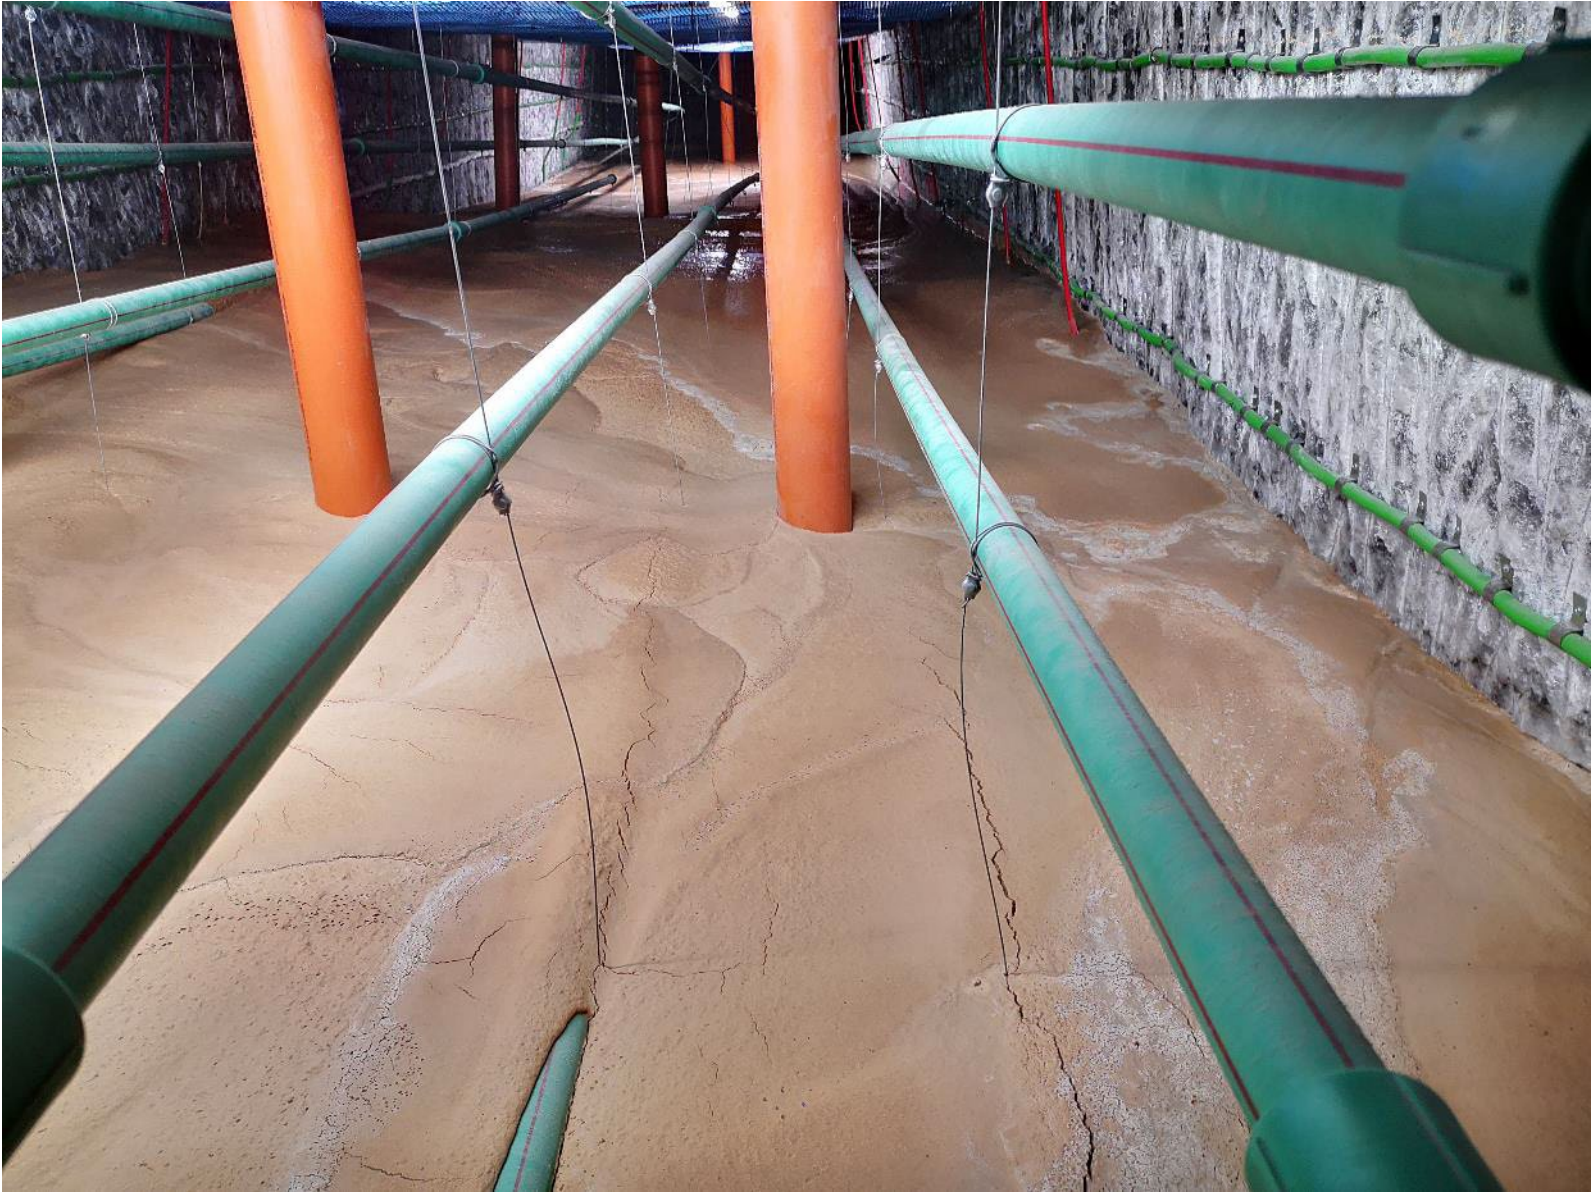
Crack formation after a 2 hours break; July 27<sup>th</sup> 2021- 16:36
