# Fluidic functional verification for closing structures and fluid-based sealing of the contact zone STROEFUN III

Julius Bauermeister, Nina Müller-Hoeppe  
TU Clausthal, BGE Tec

**US/GERMAN WORKSHOP**

Salt Repository Research,  
Design, & Operation

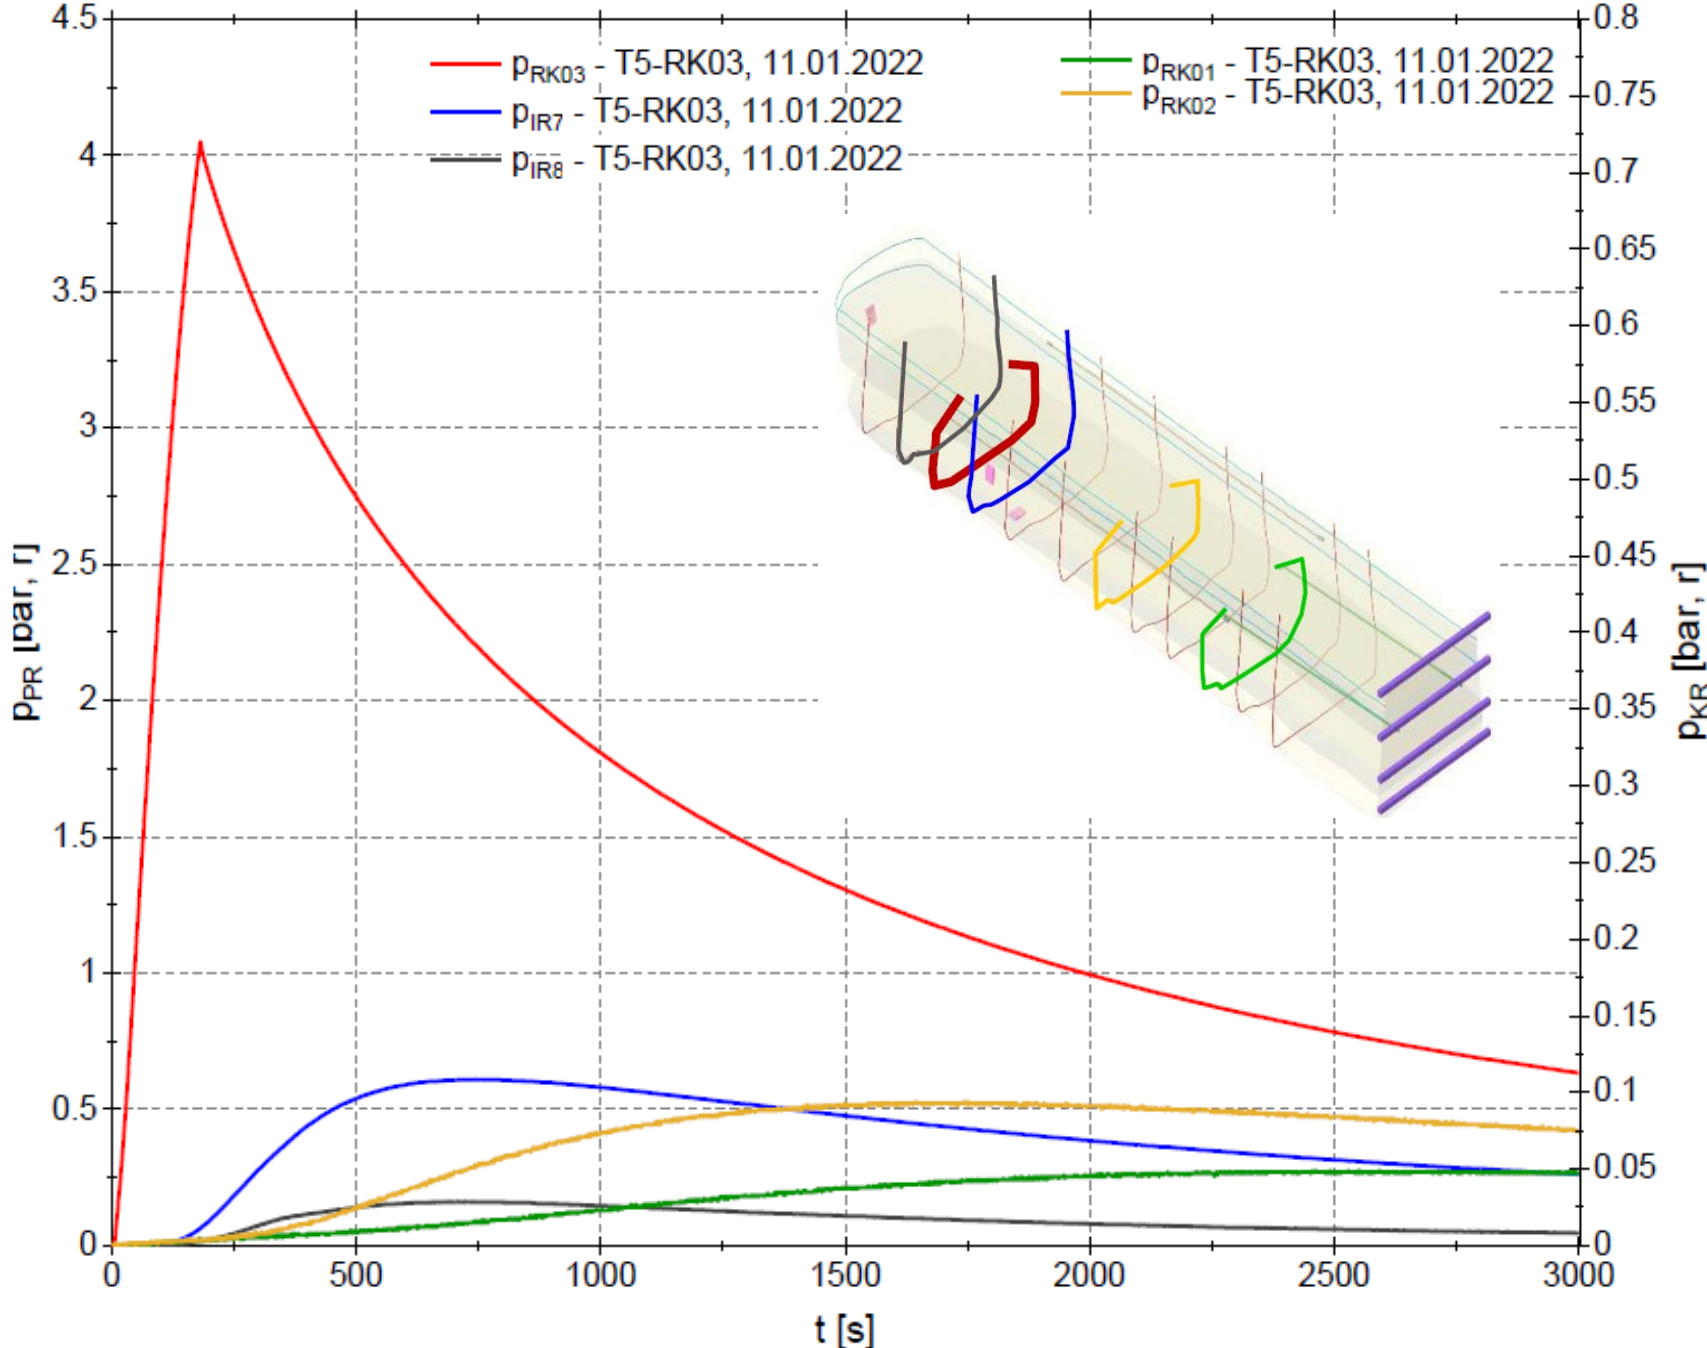
# Permeability Measurement

Measured date	Tested control chamber	Permeability between CC 1 und CC 2 [m <sup>2</sup> ]	Permeability between CC 2 und CC 3 [m <sup>2</sup> ]
01/21/2022	01	$8,0 \times 10^{-15}$	$3,0 \times 10^{-15}$
06/13/2022	01	$7,0 \times 10^{-15}$	$9,0 \times 10^{-16}$

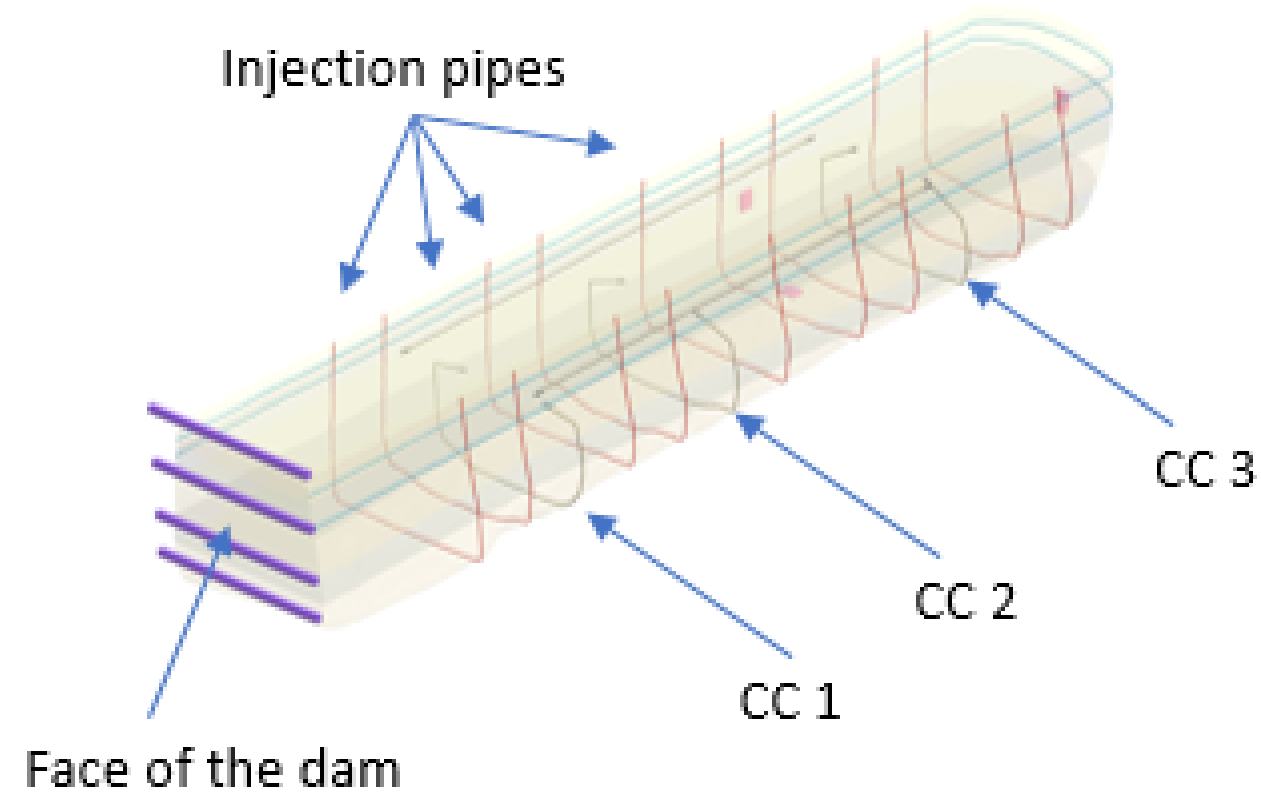
# Injection

- Injection of 1,8 L of injection grout have been injected at the last injection pipe at a pressure of 18 bar
- Afterwards 7,0 Liter of Epoxy was injected in the same injection pipe (40 bar)
- Injection in the first two injection pipes failed (70 bar) using an injection grout
- While cleaning, an attempt was made to injection the cleaning liquid, a particle free  $MgCl_2$ -solution. 0,075 Liter have been injected (65 bar)
