SDIMI 10th Internal Conference 15-17 September 2022

Fluidic functional verification for closing structures and fluid-based sealing of the contact zone (STROEFUN III)

Julius Bauermeister

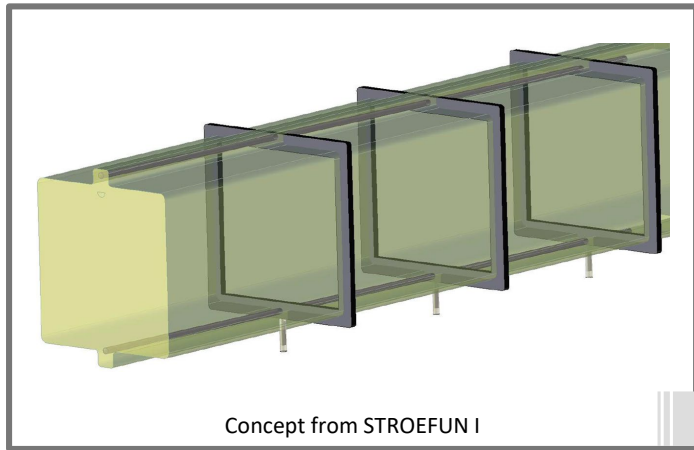
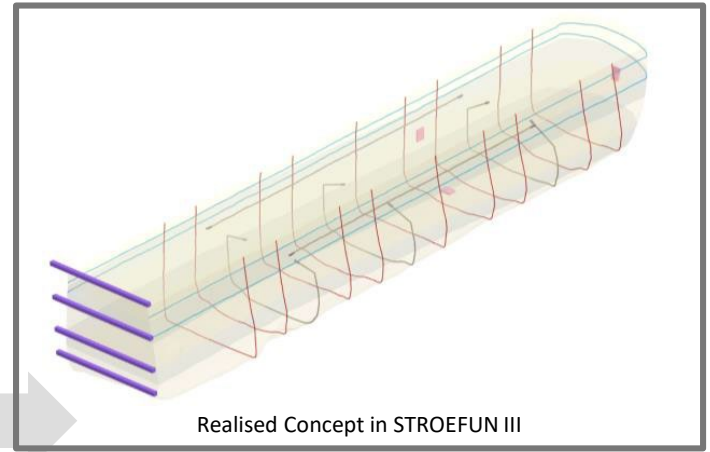
Control chambers which can estimate the integral permeability between each other

- Air pressure wave is applied to the contact zone
- Monitored by the chamber system along the rock contour

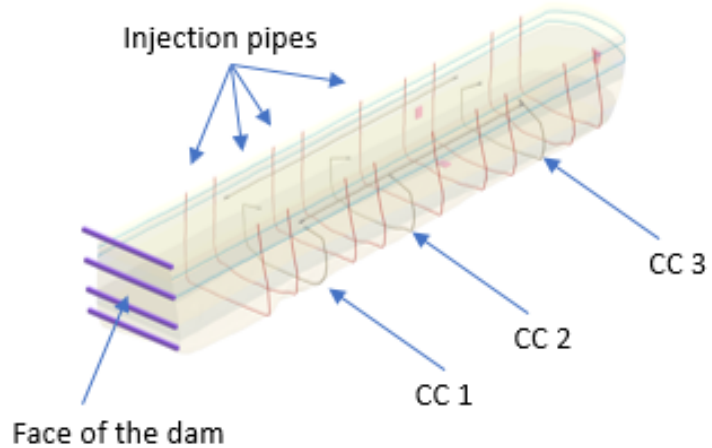
Overview of the installed measurement, test and injection infrastructure

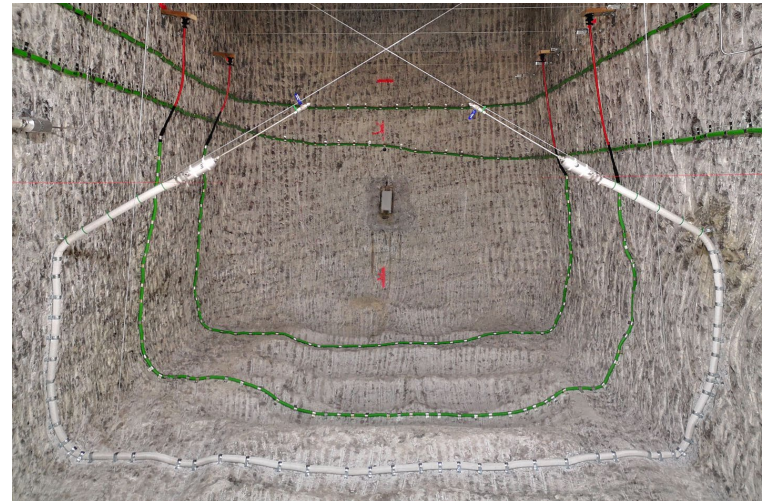
Pre-installed CC3 (without connecting pipes)

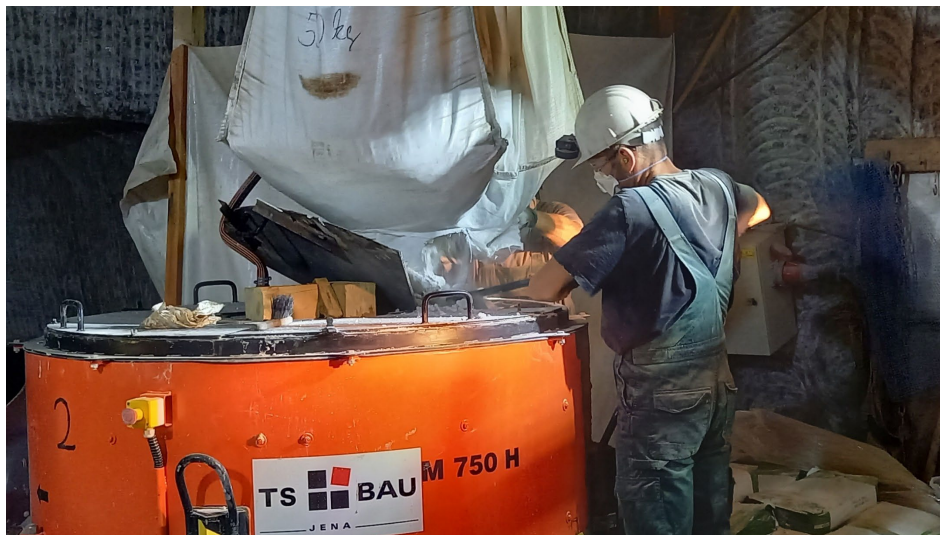
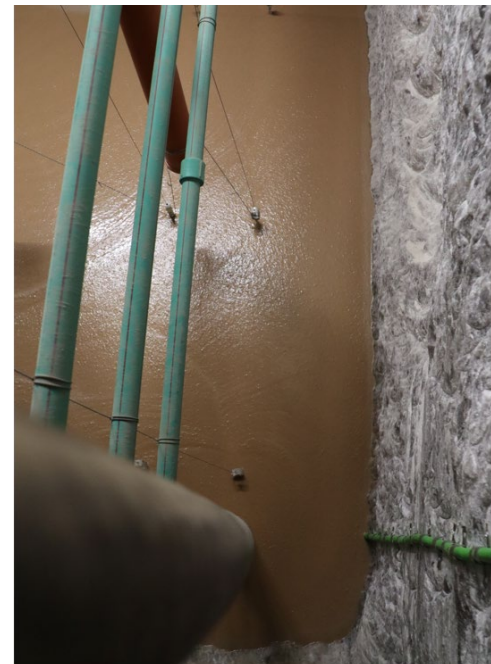
- The concrete is based on the A1-recipe from the BGE Tec
 - Anhydrate as an additive

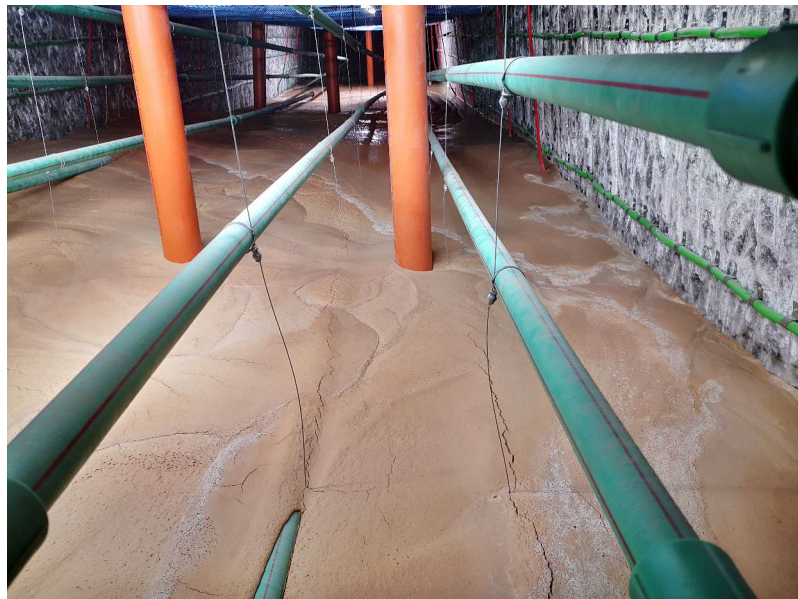
Crack formation after a 2 hours break; July 27th 2021- 16:36

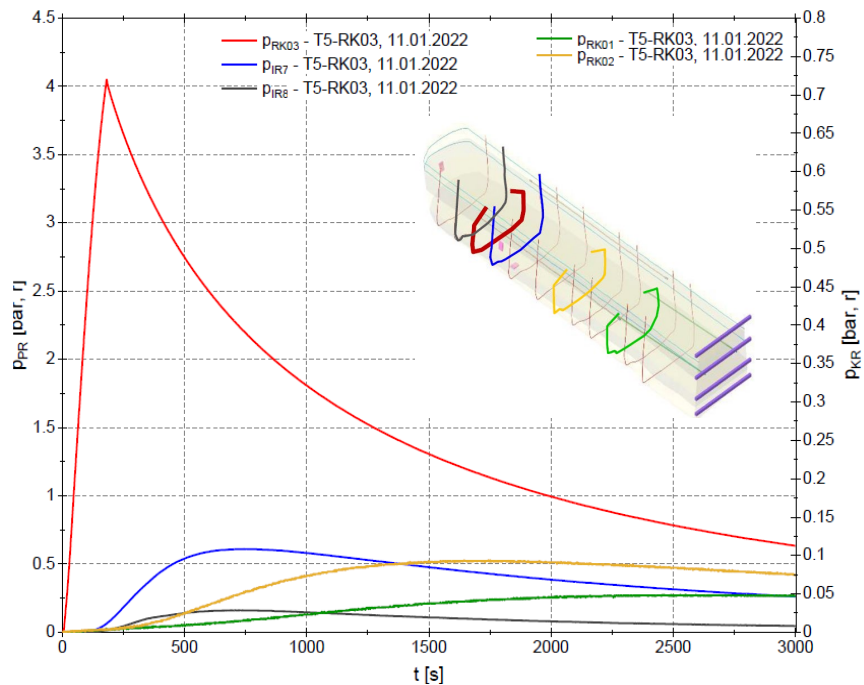
Measured date	Tested control chamber	Permeability between CC 1 und CC 2 [m ²]	Permeability between CC 2 und CC 3 [m ²]
01/21/2022	01	$8,0 \times 10^{-15}$	$3,0 \times 10^{-15}$
06/13/2022	01	$7,0 \times 10^{-15}$	$9,0 \times 10^{-16}$

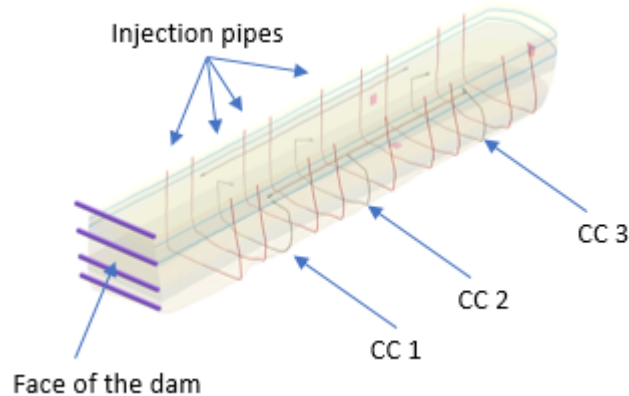
- Injection of 1,8 L of injection grout have been injected at the last injection pipe at a pressure of 18 bar
- Afterwards 7,0 Liter of Epoxy was injected in the same injection pipe (40 bar)
- Injection in the first two injection pipes failed (70 bar) using an injection grout
- While cleaning, an attempt was made to injection the cleaning liquid, a particle free $MgCl_2$ -solution. 0,075 Liter have been injected (65 bar)
